Universal Design Analysis at Emergency Room (Adam Building) Roemani Hospital, Semarang

Keywords: Universal Desain, Disability, Public Area, Hospital

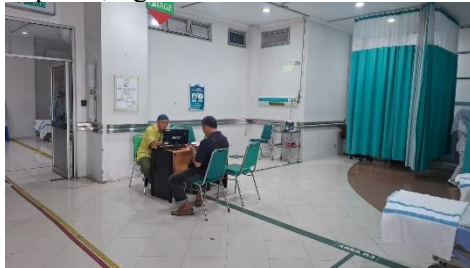
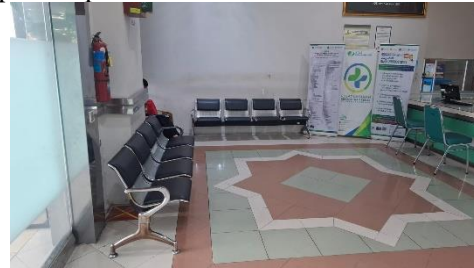
Figure 2. Waiting Room Picture

The emergency room area has been marked with large emergency room signs at the entrance. The reception area in the emergency room has implemented a zoning system with colorful lines according to the level of urgency. Green indicates areas with a low level of emergency, while red indicates the highest level of emergency. These measures are an implementation

of the universal design principle of Perceptible Information. Officers can understand these signs. The patient waiting area is quite spacious and allows wheelchair users to wait in this area. Wall handles are available on the walls to assist patients and family members who have difficulty walking, in line with the principle of Equitable Use. The receptionist is quite informative, but the registration method is still manual. The lighting in the room is relatively adequate, both natural and artificial. In areas where procedures and observations are required, lights have been installed at those specific points.

- a.) The emergency room reception area is quite easy for everyone to know because it has a fairly clear sign and is strategically located. The application of Perceptible Information has been implemented quite well. The staff in the reception area is quite informative. The method used is still manual, because officers have to sort patients based on categories to their respective emergencies.

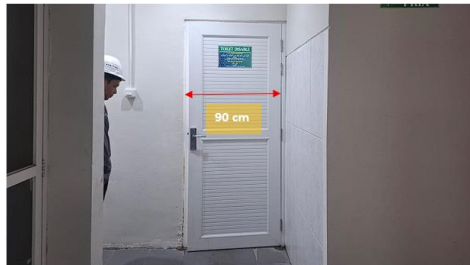
Figure 4. Toilet's Door Picture

The toilet in the emergency room has fairly good facilities, including a 90 cm wide door with an outward opening. Inside the toilet, there is a handle bar for people with disabilities to stand up in accordance with the application of the Size and Space for Approach and Use principle, in accordance with PUPR Regulation No. 14 of 2017, which stipulates that the height of the handle bar for disabled toilets is 70 cm and the height of the monoblock toilet is 46 cm. The difference in elevation between the bathroom and the corridor floor is addressed with a ramp. The mirror is installed 1.90 meters from the floor, and the sink is 74 cm from the floor.

- b.) The toilets in the emergency room have quite good facilities and facilities that support disabilities are available, including the provision of handle bars, door widths that can be passed by wheelchairs, ramps for connecting different elevations. In addition, mirrors and sinks are also installed for all users to use. The principles applied in the toilet area of the emergency room are Size and Space for Approach and Use.

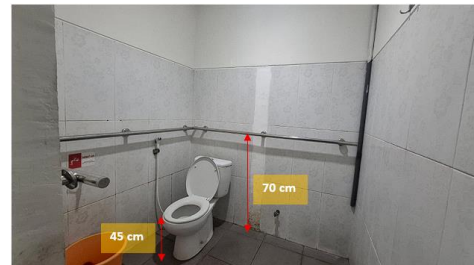
Figure 5. Interior Toilet Picture

The position of the wastafel is at least 70 cm – 85 cm.	Wastafel placement position 74 cm from the floor	meet the standards
	Installation of mirrors 90 cm from the floor.	The mirror is installed 90 cm	meet the standards
Ramp	The minimum slope of the ram in the building is 6°. The minimum slope of the ram outside the building is 5°.	The ramp in the building in the 7° slops.	does not meet the standards

- a.) Creating innovations to make information more accessible by utilizing digital technology.
- b.) Improving the slope of ramps and safety facilities in ramp areas.
- c.) Conducting periodic inspections of facilities in disabled toilets.

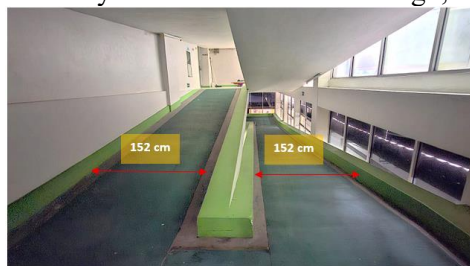
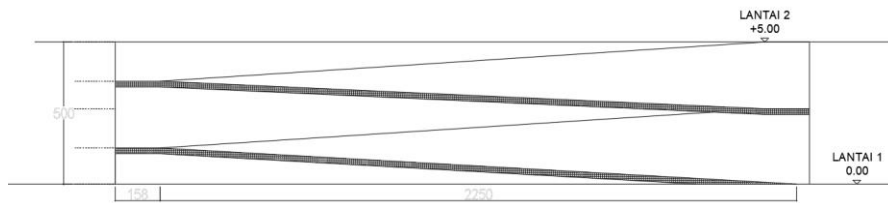
Figure 6. Ramp Picture

To connect the first floor and the floors above it, as well as to provide patient evacuation access, the emergency room area uses a ramp as vertical access. The ramp is designed using reinforced concrete and anti-slip textured carpet to prevent slipping. The ramp has a slope of less than 7° so that users can comfortably cross it. In accordance with the principles of Low Physical Effort universal design, users do not feel fatigued when using this facility.

- c.) Vertical connection facilities available in the emergency room area are stairs, elevators and ramps. Each facility for vertical relationships in the emergency room area has been sized according to the standards in PMK regulation and has also implemented the principle of Low Physical Effort. However, the ramp has a slope that has not met the standard.

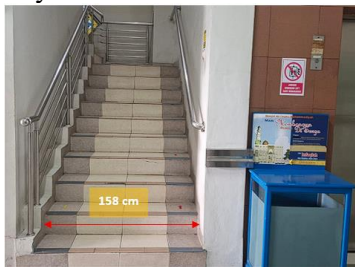
Figure 8. Stairs Picture

As a vertical connector, the stairs in the emergency room area are used as an evacuation route and also as a means of access for patients' families and staff. The standard requirements for stairs are a minimum width of 120 cm, a maximum distance between stairs of 40 m, an optrade of 15-18 cm, an antrade of at least 30 cm, equipped with handrails, and adequate lighting. Based on observations in the field, the staircase width is 158 cm with a rise of 30 cm and a run of 17 cm. This analysis is in accordance with the principles of Low Physical Effort Universal Design.

Stairs	The minimum width of the stairs is 120 cm. Optrade minimum 15 cm and maximum 18 cm Antrade is at least 30 cm.	Staircase width 158 cm. Optrade 17 cm. Antrade is at least 30 cm.	meet the standards
Lift	The minimum door opening is 110 cm. Elevator Size 120 cm x 230.	Elevator door opening 120 cm. Elevator Size 120 cm x 240.	meet the standards
Corridors	Standard corridor width 152 cm. The minimum handrail installed is 65 cm – 80 cm from the floor.	Corridor width 340 cm. The installed handrail 131 cm from the floor.	meet the standards

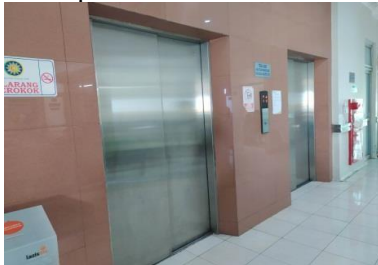
Figure 9. Hospital Lift Picture

In addition to stairs for specific situations as a vertical connection, patients, their families, and staff can use the elevator in the emergency room area to access the first floor and the floors above. The elevator requirements based on standards are a minimum effective size of 120 cm x 240 cm with a minimum door opening width of 120 cm. The elevator doors are equipped with automatic sensors. Two elevator units are located in the center of the east side of the building, adjacent to the stairs. The passenger elevator is used for vertical circulation between floors, from the first floor to the fourth floor. The elevator size meets the requirements. The elevator wall finish uses maroon-colored granite material.

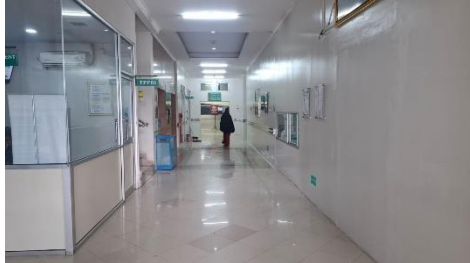
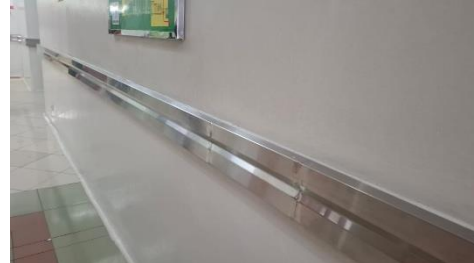
Figure 10. Hospital Corridors Picture

The horizontal access in the emergency room area is a hallway. The use of wall guards installed 131 cm from the floor on this wall is an application of the universal design principle of Equitable Use, whereby all users in the corridor can pass through this room without difficulty, whether they are healthy or disabled. The corridor in the emergency

department area is 340 cm wide, allowing patient beds to pass through. This is in accordance with PMK No. 40 of 2022, which stipulates that the width of corridors and hallways for two patient beds passing each other must be at least 240 cm. The following are the results of observations in the room.

- d.) For horizontal connections, the corridor has been built to good standards, the size is quite wide and there are wall guards or hand railings installed on the wall.
